March 2, 2012

**Subject: Final Letter Report
Polychem Services, Inc. (Polychem Services), Site Emergency Response
Chicago Heights, Cook County, Illinois
Technical Direction Document No.: S05-0001-1202-001
Document Control No.: 1733-2A-AUHM
Contract No.: EP-S5-06-04**

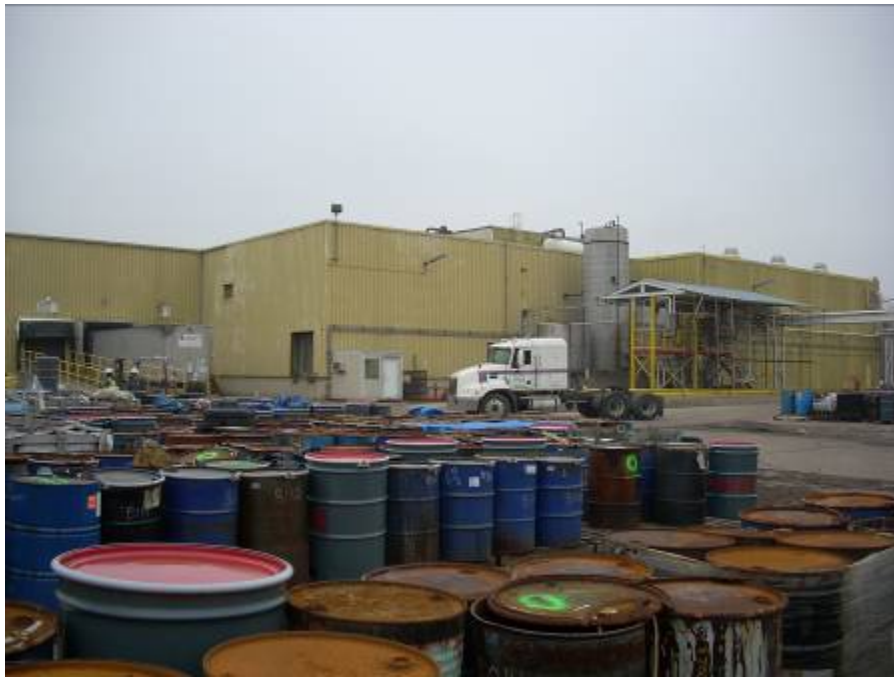
Photograph No.: 1

Subject: Chemical conversion facility and staged drums in northwest region of the Site

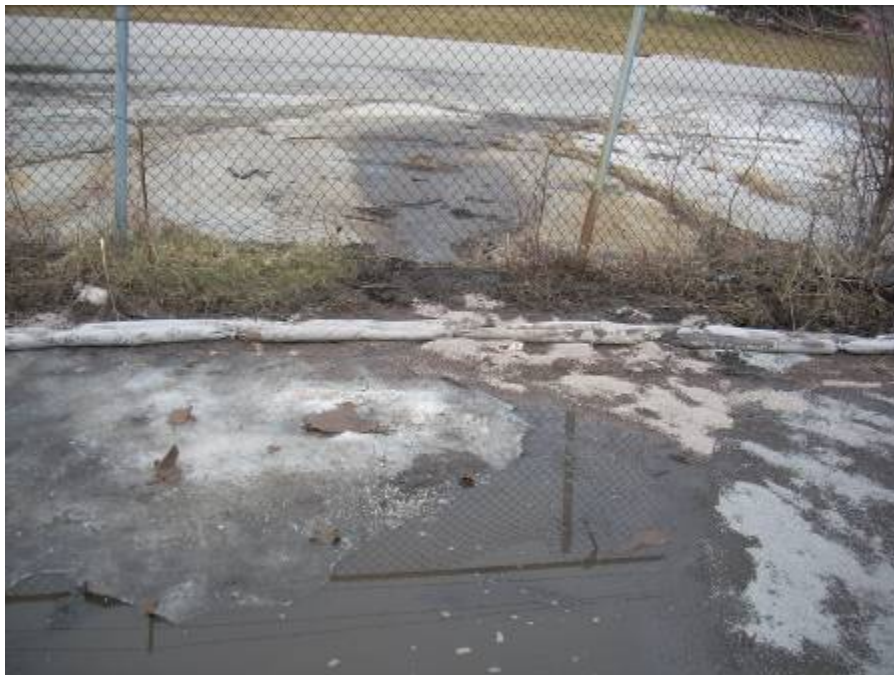
Photograph No.: 2

Subject: Soil berm and absorbent boom along Site's west fenceline

Mendoza and WESTON START arrived at the Site and met with Polychem Services representatives. Polychem Services had installed a soil berm and an absorbent boom along the northwest fenceline of the Site where surface water runoff from the northwest drum staging area had been flowing into a storm sewer (**Photograph No. 2 in Attachment B**). Polychem Services also applied Oil-Dri to an area where oily product had been accumulating around leaking and open drums (**Photograph No. 3 in Attachment B**). WESTON START used spray paint to mark and document all leaking, open, and damaged drums and totes in the west and northwest regions of the Site.

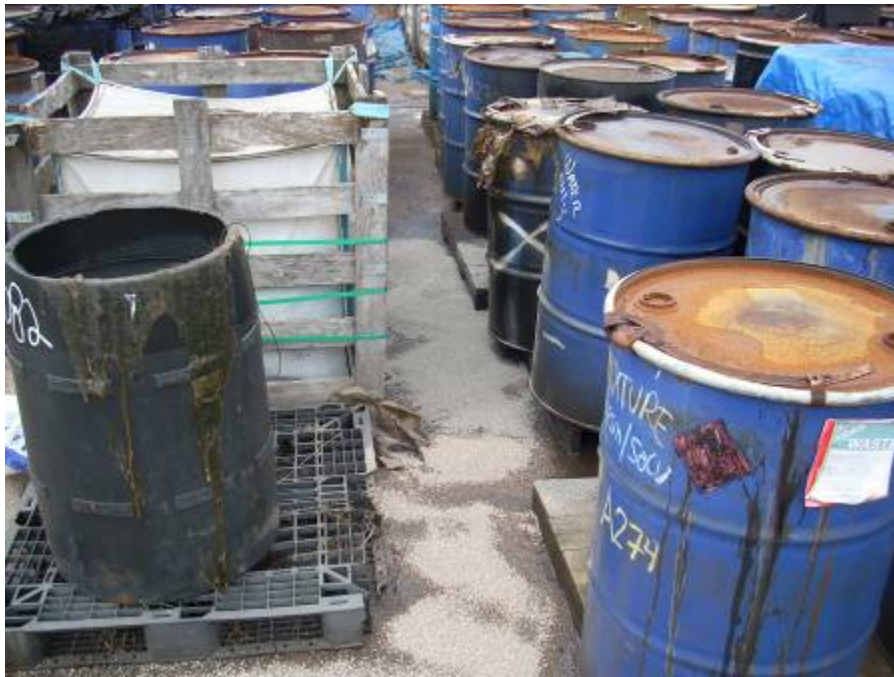
Photograph No.: 3

Subject: Oil-Dri absorbent applied to area of pooled product leaking from 55-gallon drums

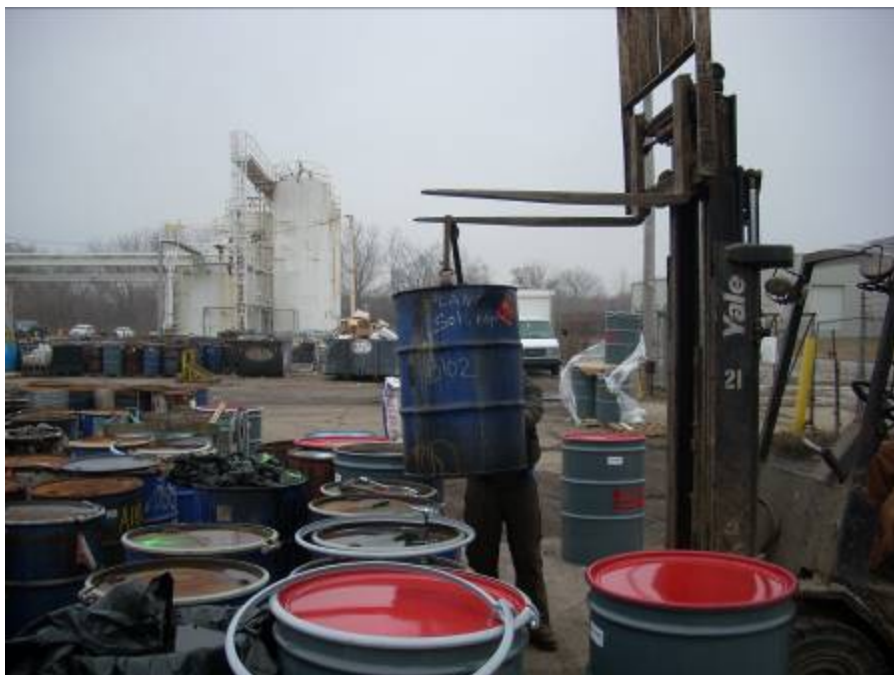
Photograph No.: 4

Subject: Leaking 55-gallon drum labeled "Plant Solvent" and "Flammable" being placed into an 85-gallon steel overpack drum

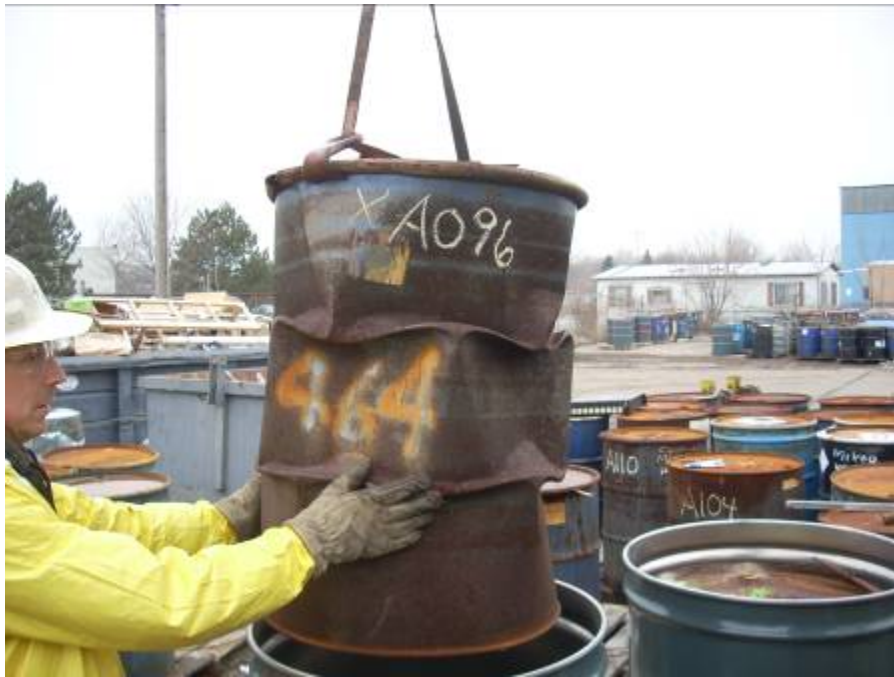
Photograph No.: 5

Subject: Damaged 55-gallon drum being placed into an 85-gallon steel overpack drum

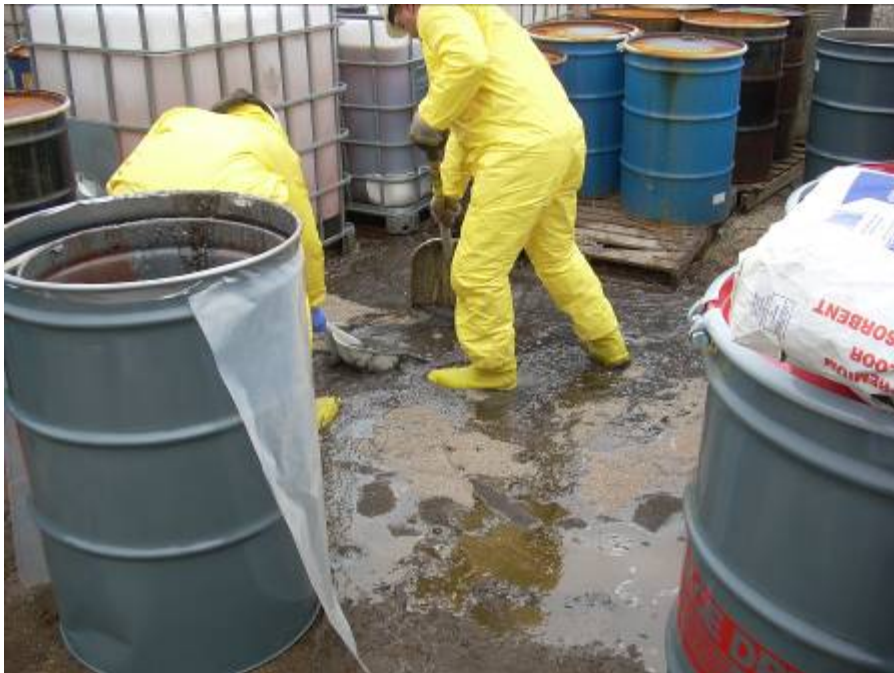
Photograph No.: 6

Subject: : Shoveling and disposal of Oil-Dri absorbent used to clean a spill of non-hazardous, under-reacted phenolic resin from 55-gallon steel drum in the northwest region of the Site

WESTON START conducted air monitoring for VOCs during all ER operations using a MultiRAE photo-ionization detector (PID) and marked each overpack drum with identification information. At 1:40 p.m. on February 3, R3 Environmental accidentally spilled the contents of an unlabeled leaking drum. The facility operator from Chemtech, Mr. Tom Riggins reported that the material was non-hazardous, under-reacted phenolic resin. WESTON START used the PID to monitor air near the spill and did not detect VOCs above the background level. R3 Environmental bermed and covered the spill with Oil-Dri absorbent, allowed the liquid to be absorbed, and shoveled the material into an 85-gallon steel overpack drum (**Photograph No. 6 in Attachment B**).

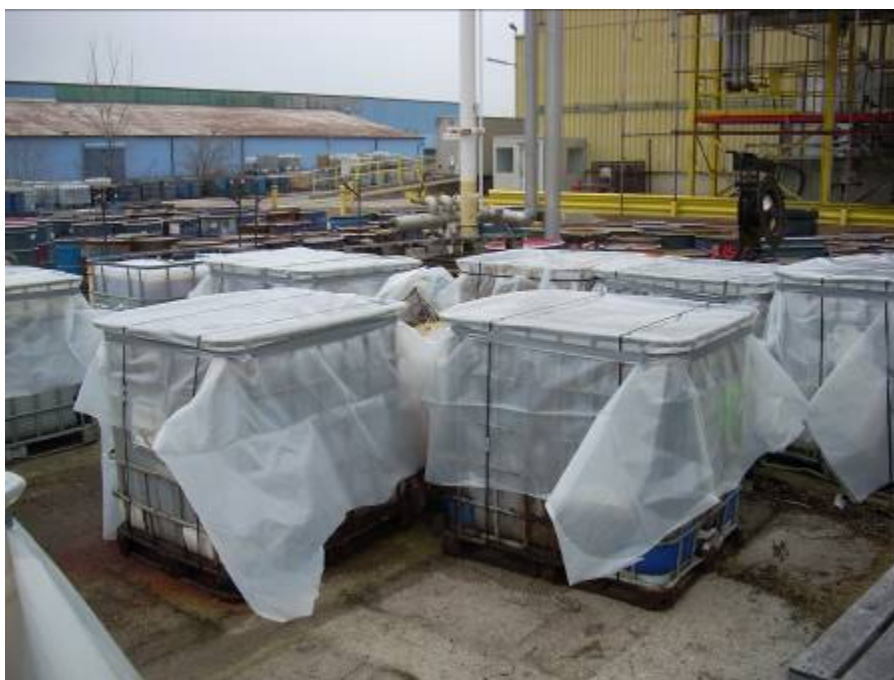
Photograph No.: 7

Subject: Open 270- and 330-gallon totes covered with 6-mm Visqueen and secured with plastic straps and duct tape.

On February 6, 2012, at 8:00 a.m., R3 Environmental sealed two 330-gallon and six 270-gallon open and cracked totes with 6-millimeter (mm) Visqueen wrap and sealed the Visqueen with plastic bands and duct tape (**Photograph No. 7 in Attachment B**). At 8:45 a.m., U.S. EPA and WESTON START identified a small spill of red liquid beneath a 270-gallon tote in the northwest region of the Site (**Photograph No. 8 in Attachment B**). The red liquid had a field pH of 13 standard units (SU). Polychem Services secured the leaking tote by transferring it inside the facility building. Polychem Services stated that it will pump the contents of the leaking tote to a secure tote. Oil-Dri absorbent was applied to the spill area, and R3 Environmental scraped the material into a 55-gallon drum (**Photograph No. 9 in Attachment B**). At 9:30 a.m., R3 Environmental secured lids on four unlabeled, leaking, 55-gallon steel drums in the northeast region of the Site belonging to Polychem Services. At 12:30 p.m., R3 Environmental used a fork lift to place one leaking 55-gallon drum into an 85-gallon steel overpack drum. At 1:00 p.m., R3 Environmental secured lids on 13 open 55-gallon steel drums in the northwest region of the Site (**Photograph No. 10 in Attachment B**). At 2:00 p.m., R3 Environmental scraped contaminated Oil-Dri absorbent from the area of pooled oily product and

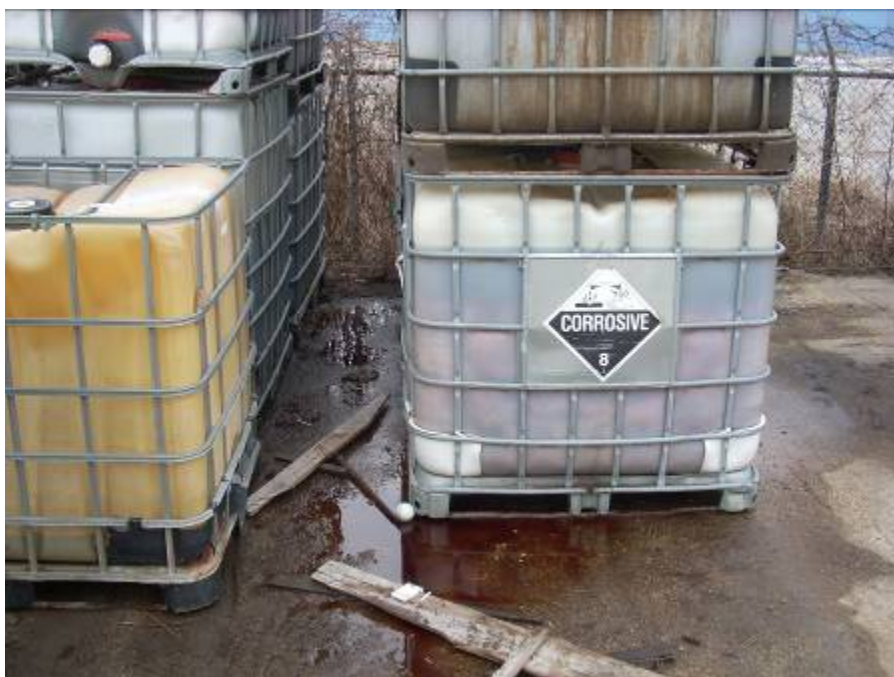
Photograph No.: 8

Subject: Spill of red caustic liquid from a 270-gallon tote in the northwest region of the Site

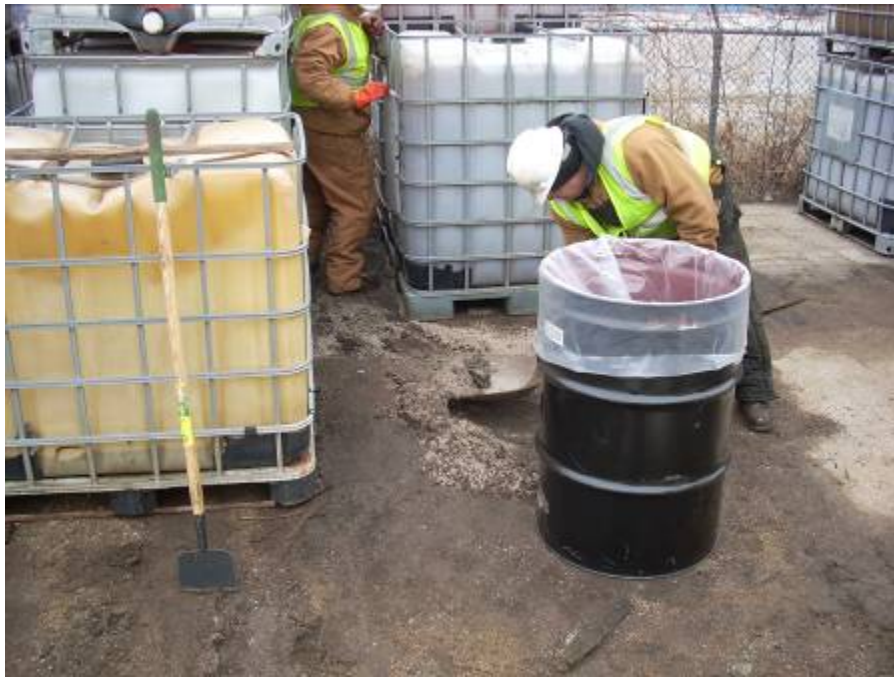
Photograph No.: 9

Subject: Shoveling and disposal of Oil-Dri absorbent used to clean a spill of red caustic liquid from a 270-gallon tote in the northwest region of the Site

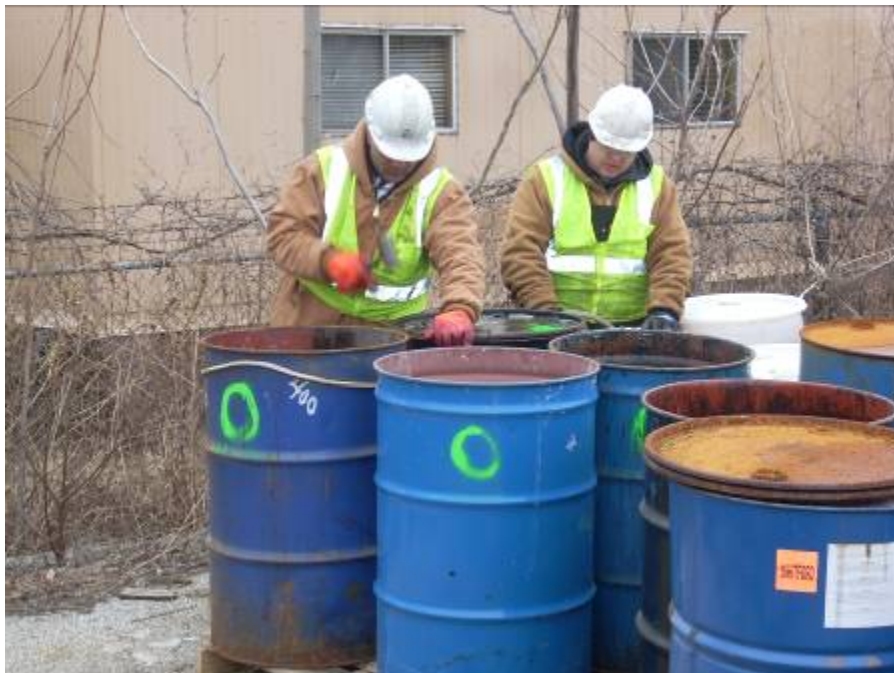
Photograph No.: 10

Subject: Lids being installed on open 55-gallon drums in the northwest region of the Site

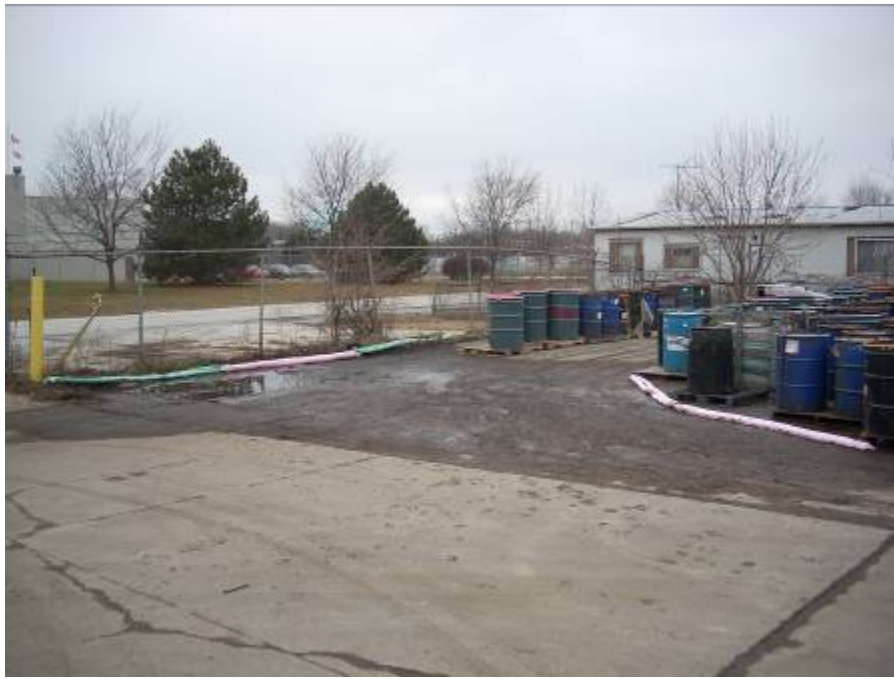
Photograph No.: 11

Subject: Absorbent boom installed along the Site's west fenceline downgradient from oil-contaminated asphalt in the northwest region of the Site

water in the northwest region of the Site into two 55-gallon steel drums. Additionally, R3 Environmental installed an absorbent boom along the northwest fenceline downgradient from oil-contaminated asphalt in the area of the drums that had been leaking (**Photograph No. 11 in Attachment B**).
